Manhole Inspection Summary

Manhole # S35SS_023MH

Insp Date: 1/19/07 1:34 PM

Location Address: **2643 27TH ST**

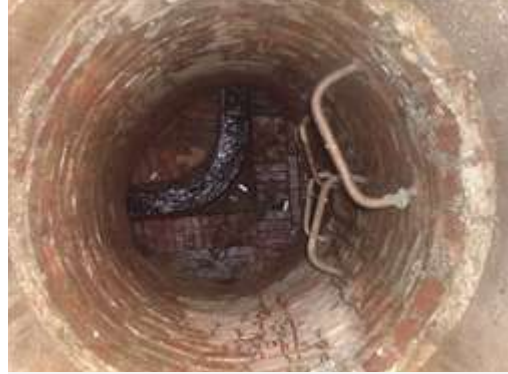
Top View

Barrel infiltration. Corroded steps. Bench debris.

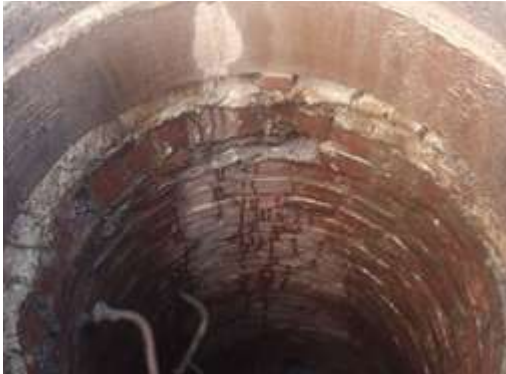
Defect

Frame leaks. Adjustment deterioration, loose brick and infiltration. Corbel deterioration and infiltration.

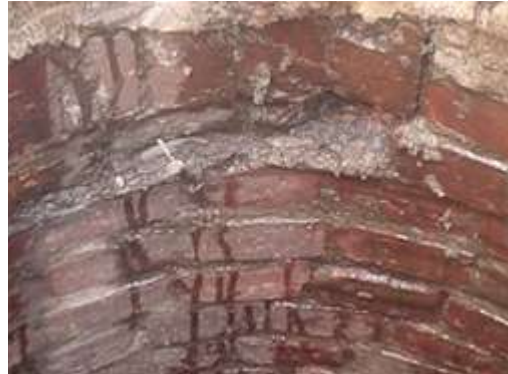
Defect

Corbel deterioration and infiltration.

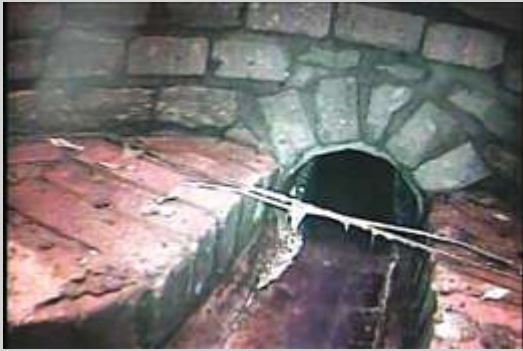
8 in. Circular Gravity Sewer Pipe Out @ 12 O'Clock

Deposits: ☐ None ☐ Mud ☐ Sludge ☐ Debris ☒ Grease

Silt Depth: **0** (in.) Deposits Extent: **Light**
